Navajo Abandoned Uranium Mine

Site Screen Report

North Star AUM Site

March 2010

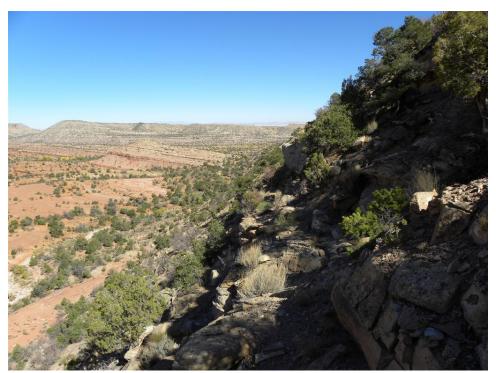
Photo 1. Mine site

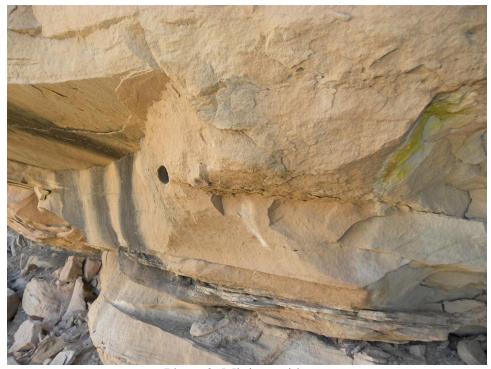
Photo 2. Mining evidence

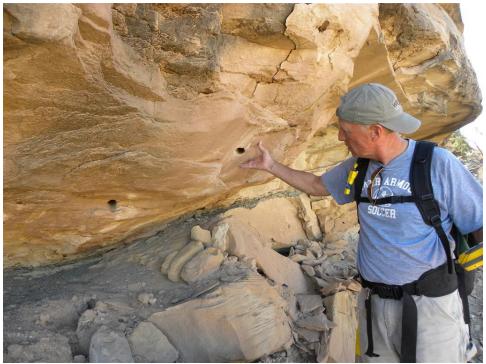
Photo 3. Drill holes

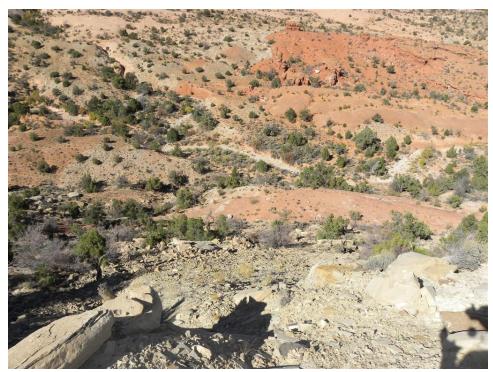
Waste rock below adits, 20' x 20' (4), with a total estimated volume of 296 yd³

Photo 5. Waste debris

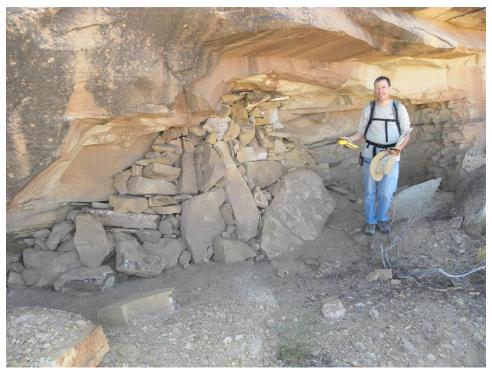
Photo 6. Sealed adit

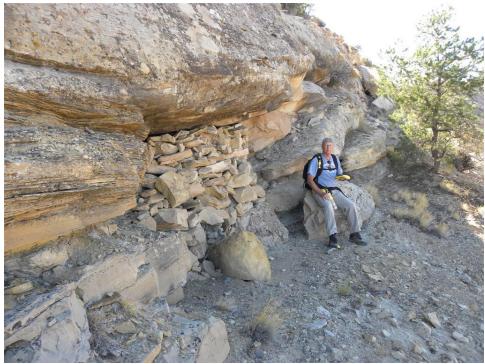
Photo 7. Sealed adit

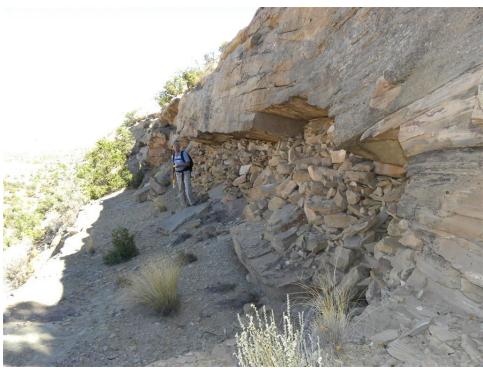
Photo 8. Sealed adit

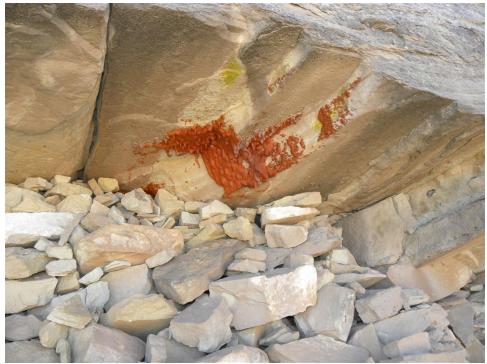
Photo 9. Sealed adit

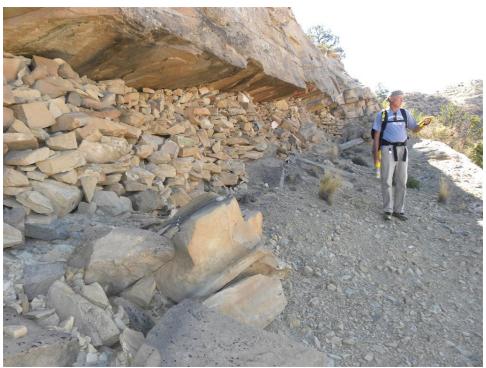
Photo 10. Sealed adit

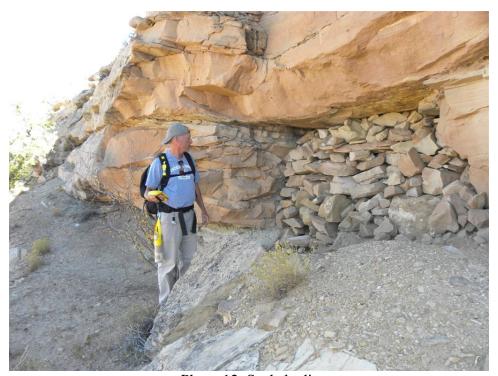
Photo 12. Sealed adit

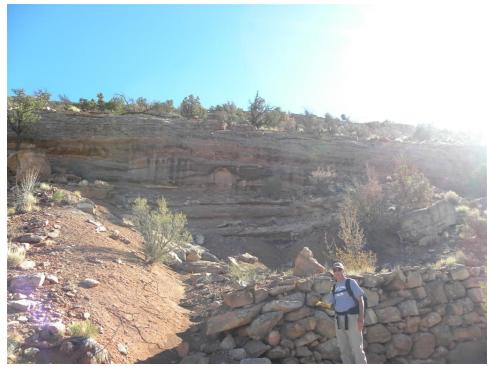
Loading area with stacked rocks at bottom of mine

Photo 13. Stacked rock

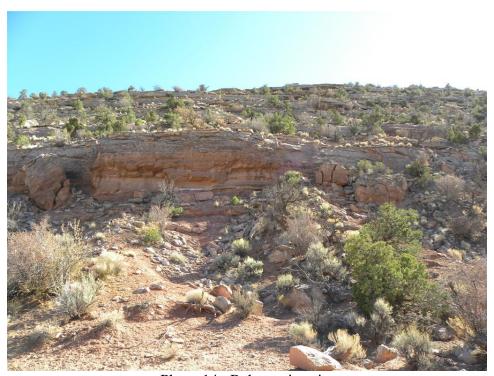
Photo 14. Below mine site
